ASDE-2 TRANSMITTER MODIFICATIONS

Federal Aviation Administration

REPORT NO. FAA-RD-72-32

SEPTEMBER 1972  
FINAL REPORT

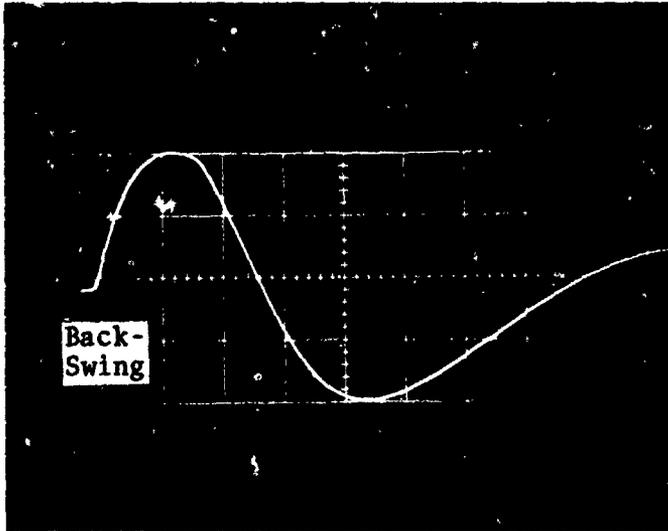
Note lack of pulse  
shape and excessive  
back swing

Present pulse  
amplifier output,  
6AQ5

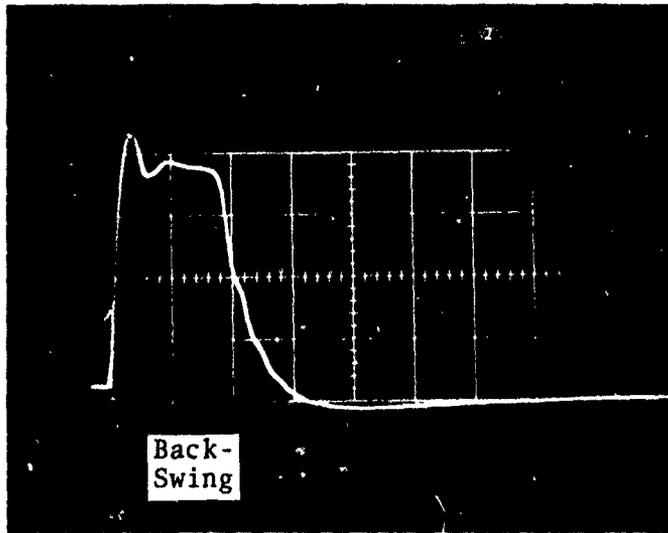
Unloaded pulse has  
very little back  
swing

Modified pulse  
amplifier output,  
6DS5

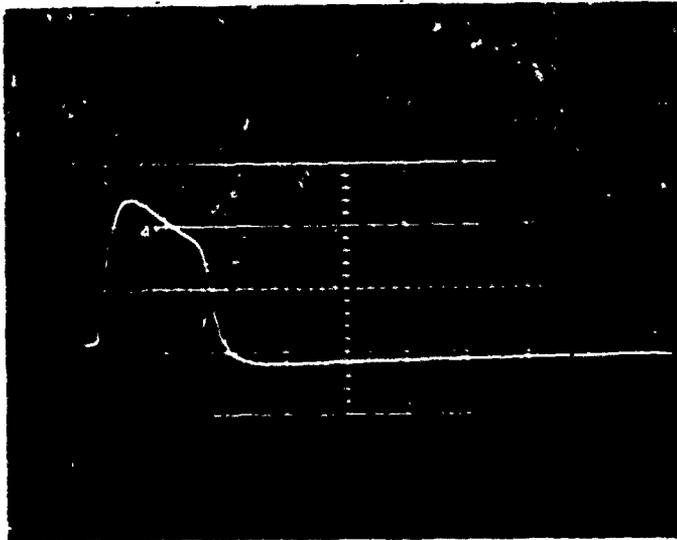
4a

The 125 volt pulse is inadequate for reliable thyatron triggering

Present pulse amplifier output, 6AQ5

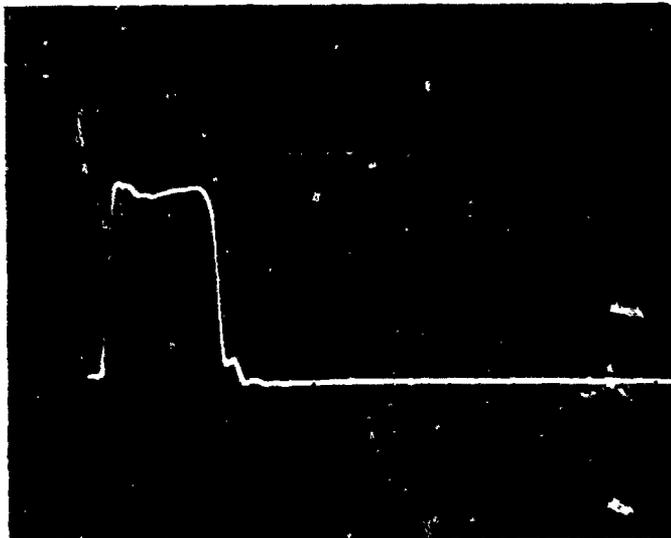
4b

Pulse output is ~ 300 volts which will provide excellent thyatron triggering

Modified pulse amplifier output, 6DS5

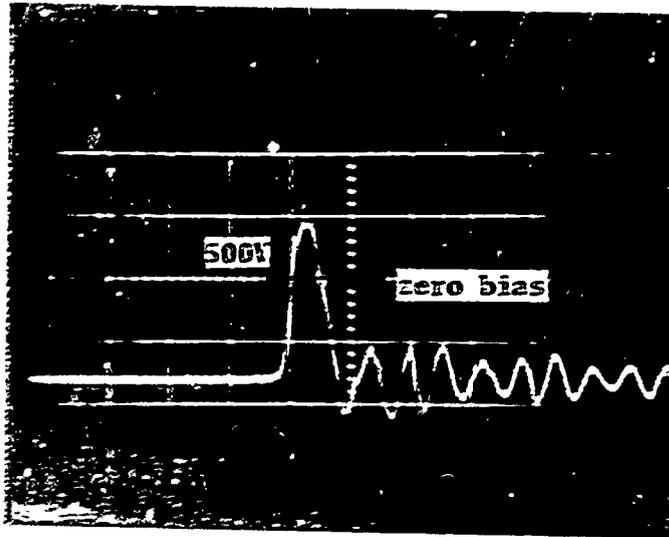
5a

4PR60's grid pulse delivered by 8765 thyratron. The portion of the pulse above the center line is the amount of grid drive and is about 350 volts

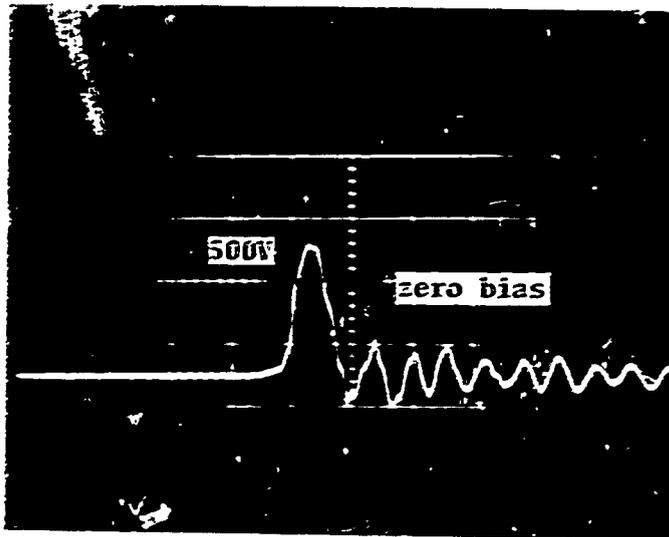
5b

The same pulse delivered by a 3C45 thyratron. The grid drive is less than 300 volts

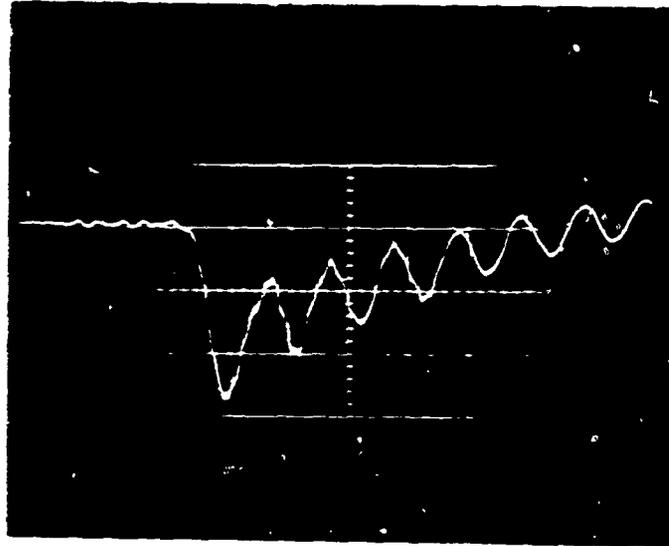
Figure 6. Magnetron Voltage Pulse

The pulse was taken with the original coupling capacitor.  
Its value is 1000pF, and it has a series inductance of  
2.0 $\mu$ H.

or 63 nanoseconds which agrees quite well with the time shown in Figure 6. Some or all of this problem could be eliminated by increasing the ringing time and the circuit damping. However, this could increase the "bleed" current from 6 to 24 amperes, and is really not a practical solution. For these reasons, other methods of preventing double pulsing were tried.

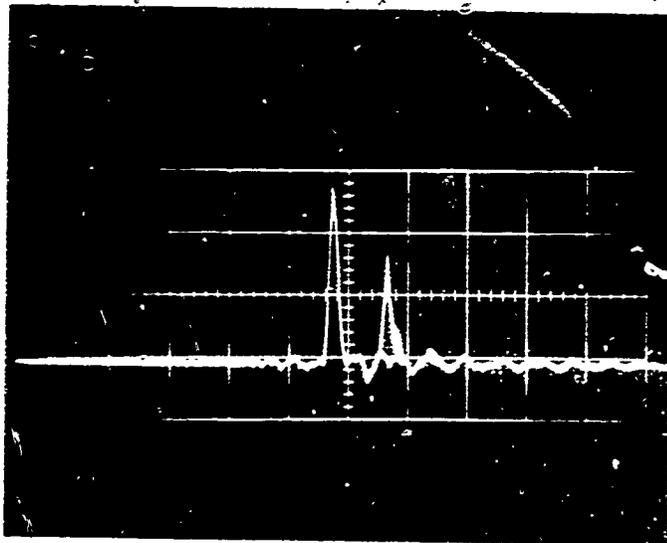
Figure 8. Magnetron Double Pulsing

This long time constant can be a serious problem for at least two reasons.<sup>4</sup> First, the magnetron may not turn off cleanly and the pulse spectrum may contain noise and cause interference with nearby targets. Secondly, the coupling capacitor may contain series inductance and result in transient oscillations of the magnetron voltage pulse during the re-charge portion of the cycle. While the spectrum noise does not appear to be serious, the ringing due to inductance is a potential problem with some magnetrons. Figure 6 shows this ringing clearly. The first crest after the main pulse may cause the magnetron to oscillate as shown in Figure 8, which should be compared to the single RF pulse shown in Figure 7.

Magnetron RF pulse (rectified) sample shows how double pulsing can occur when the magnetron voltage pulse shape is improper.

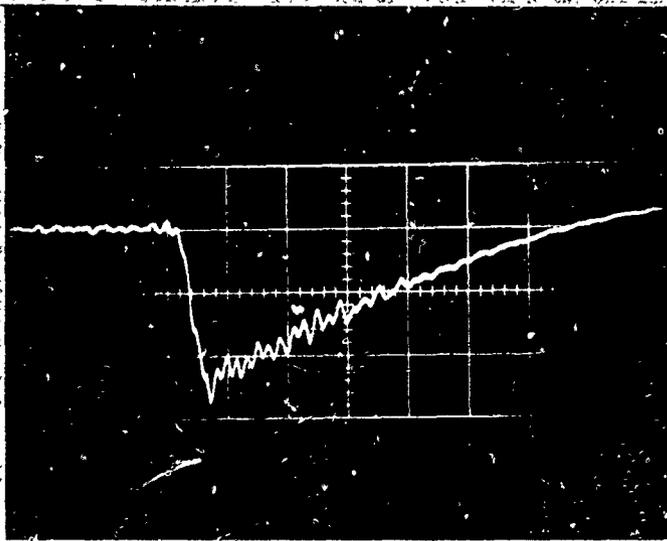
Figure 10. Magnetron Voltage Pulse with a Very Low Inductance Capacitor

A low inductance capacitor (0.2 $\mu$ H) was installed with mixed results. The ringing frequency was increased accordingly and the double pulsing was reduced but not completely eliminated. Figure 10 shows the magnetron voltage pulse with a 2000pF, low-inductance capacitor. Double pulsing was produced simply by adjusting the magnetron voltage. Figure 11 shows the magnetron voltage pulse with a 5000pF, 32 $\mu$ H capacitor. Strangely enough, double pulsing could not be produced even though the second pulse is quite pronounced. This is due to the fact that the height of the second pulse is not sufficient to turn the magnetron on.

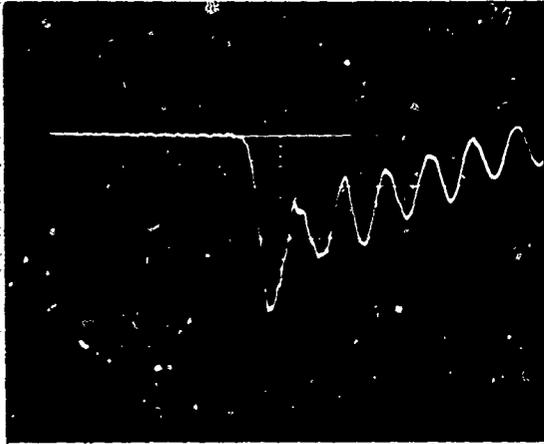
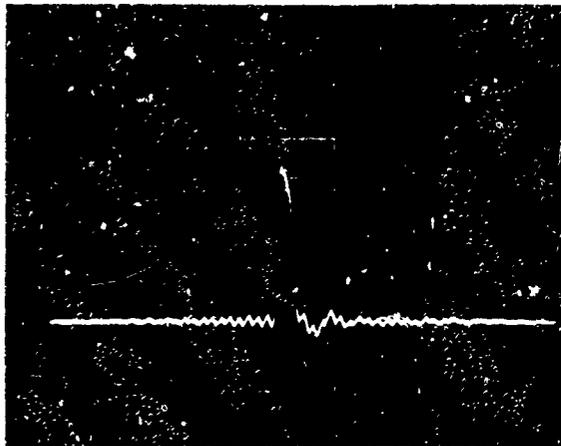
Figure 12. Magnetron Pulses with a Low Inductance 2000pF Capacitor and a 1.7 $\mu\text{h}$  Inductor in Series.

1. The modulator dc voltage could be reduced without reducing the average magnetron current.
2. The main pulse is more than 20ns wide, producing an RF pulse somewhat broader than the 16ns previously observed.
3. Double pulsing could in no way be produced, even with the magnetron that was so easily double pulsed before.
